J. Hanson Shafer Farmstead

Middletown vicinity

F-4-90
J. Hanson Shafer Farmstead
Middletown
Frederick County

State Historic Sites Inventory Form

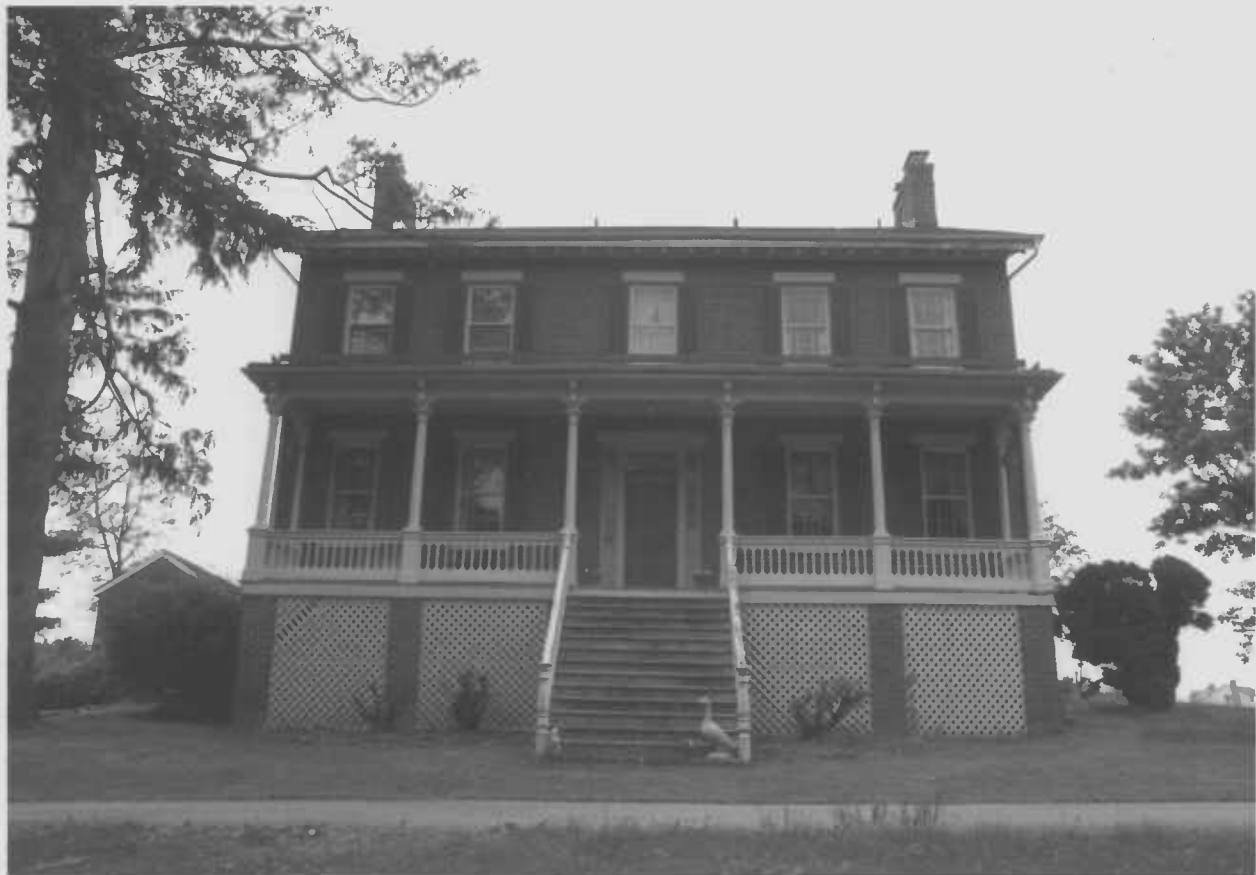
1/5

Neg. loc.: Md SHPO, Crownsville, Md.
North elevation

The dwelling's principal elevation faces north toward Marker Road and has five bays. The walls are in 5:1 American bond. The entrance is in the center bay and the first story is sheltered by a one-story porch on brick piers, with Italianate brackets, columns, and balustrade. The entrance has a transom and sidelights with paneled bases. Above the 4-panel door is a floriated console hood. The windows have plain lintels and wood sills, with 6/6 sash and louvred shutters. The cornice is bracketed and the roof is covered with composition shingles. The east and west gable ends have interior chimneys with two bays and 2/2 attic windows. A two-story rear wing extends from the southwest corner of the main section, with a single 4-panel door at the southeast corner and a second doorway at the southwest corner which is obscured by vines. In the angle between the main section and rear wing is a two-story open porch with attenuated Tuscan columns and a plain balustrade. The rear of the main section has two doors facing south and the wing has an additional door facing east. The interior of the house was inaccessible for this survey.

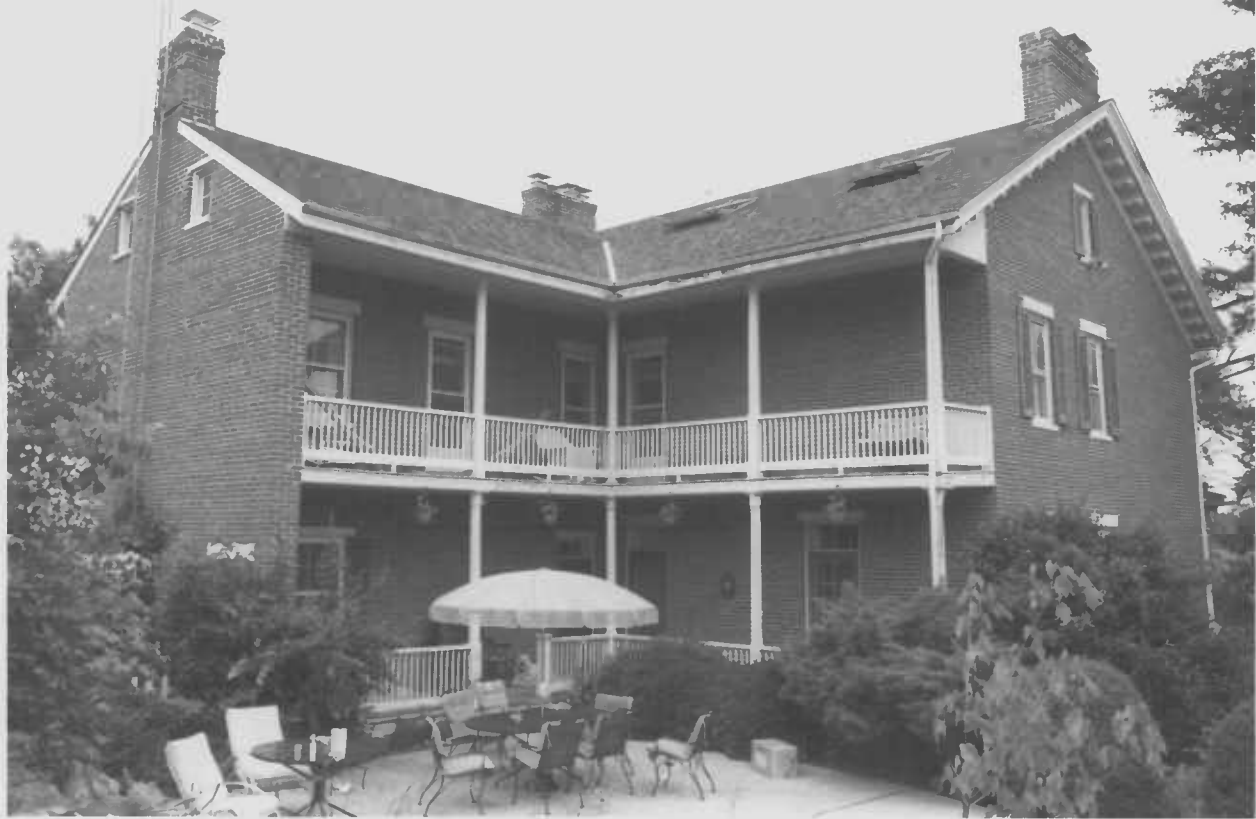
2/5

Southeast corner view

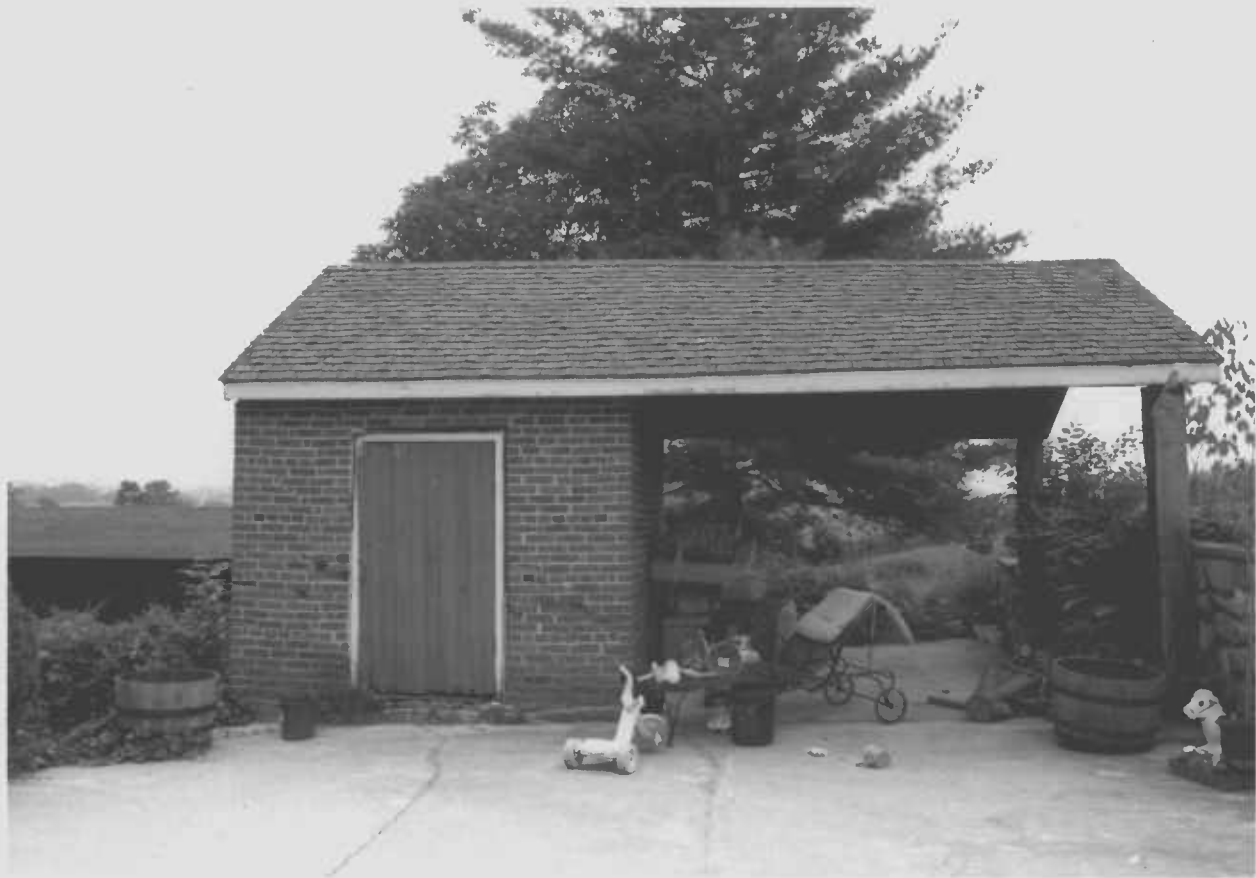
3/5

Nea. loc.: Md. SHPO. Crownsville, Md.
Smokehouse west elevation

Smokehouse: The brick smokehouse is located southeast of the rear wing. Built about 1830 with the dwelling, it has a generally rectangular plan with a vertical board door in the west elevation and vent openings in the north and south gables. The composition shingle roof extends on the south to form an open wood shed.

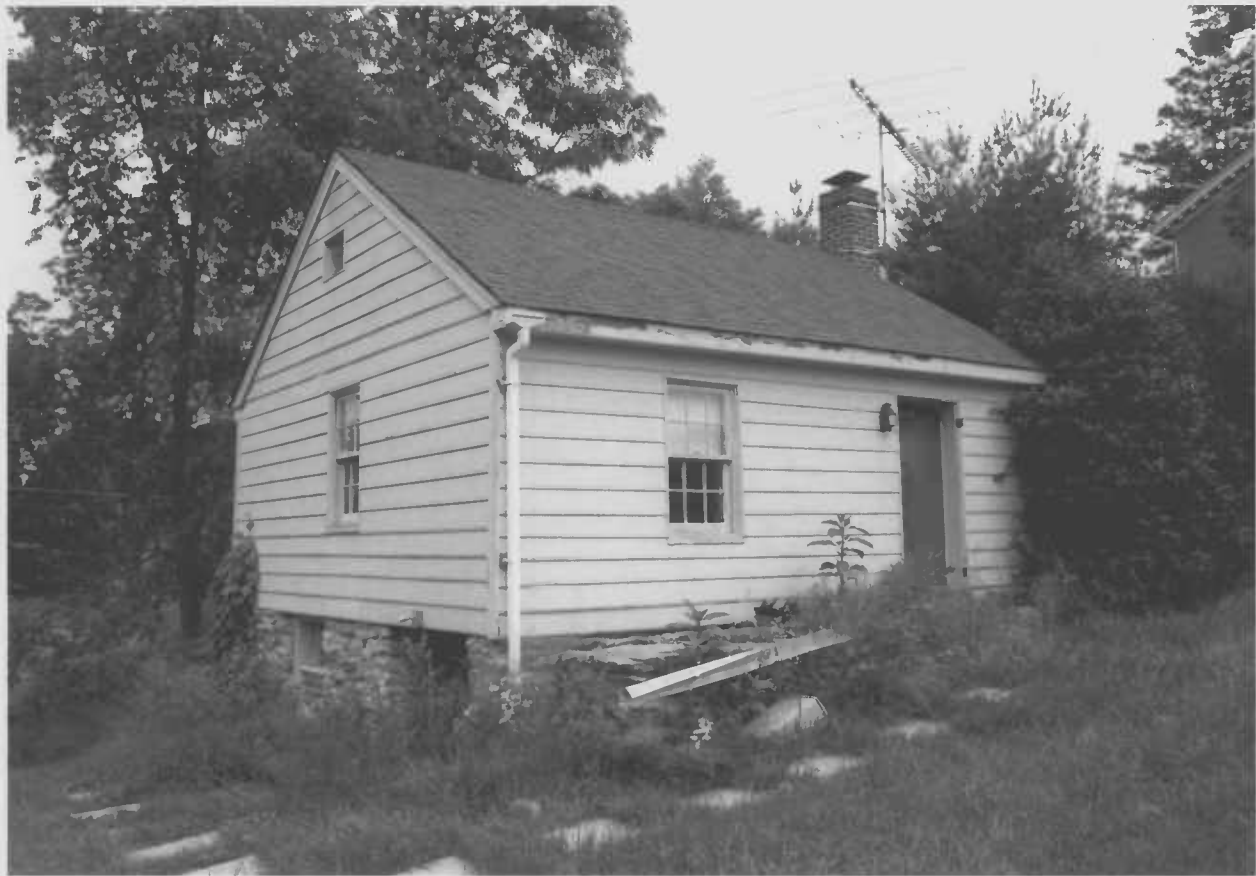
4/5

Neg. loc.: Md. SHPO. Crownsville Md.
Springhouse, South elevation

Springhouse: The springhouse is located southwest of the dwelling. It has a stone lower level, but the upper section is covered with modern pressboard siding, concealing the original structural material, which may be either log or frame. An exterior brick chimney has been rebuilt on the east elevation. A vertical board door is in the north elevation, lower level, with 6-light windows. Two other doors are located in the south and west elevations. The upper level has 6/6 sash. The gable roof is composition shingles. Since much of its original structure is covered or altered, the springhouse's date is obscure, but probably is about 1830 like the main house and the smokehouse.

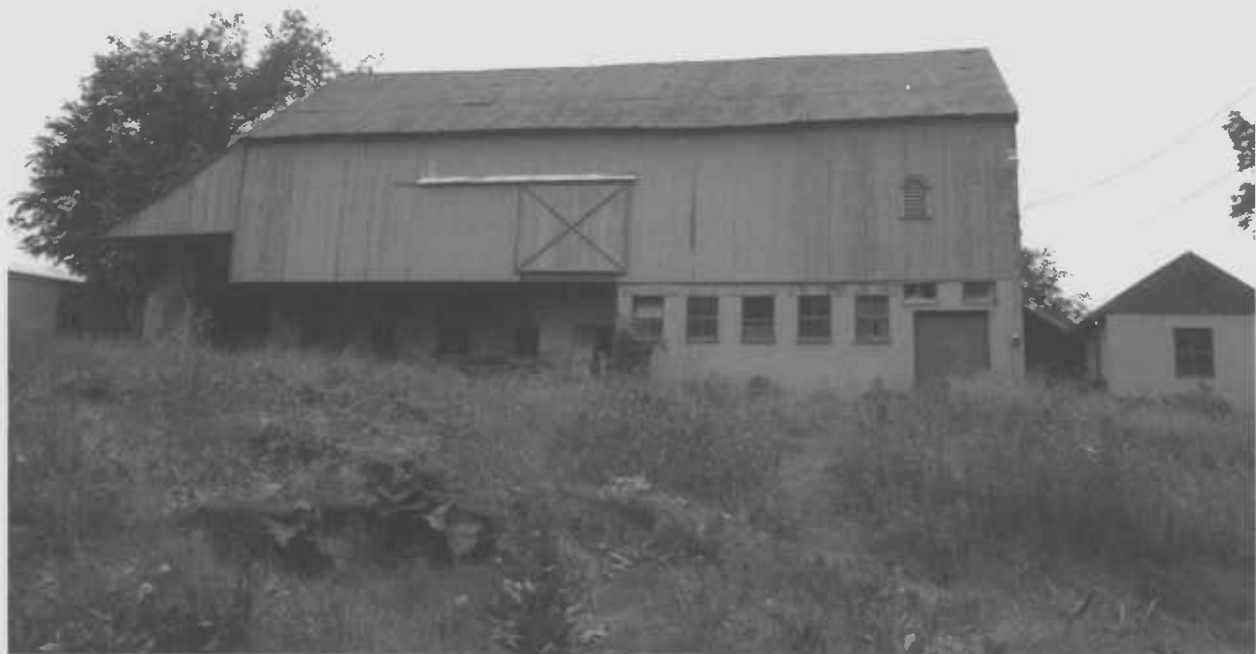
5/5

Barr and mth house, east elevation

Barn and milk house: The circa 1830 frame bank barn has a stone foundation and stall level facing east. The upper frame section has vertical siding and the gable roof is corrugated metal. The north end of the upper level and the east elevation have louvred vents with arched frames. On the south gable end is a wagon shed with a single corn crib.

The north end of the stall level is enclosed with concrete block for a milking room and the concrete block milk house built about 1930 is located just north of the barn, adjacent to the milking room. The milk house has a standing seam metal roof and composition-covered gables.
